# Saint Petersburg **Mertens House** **Panoramic Elevator**

*by Aleksey Gorilovsky and Stephan Kretschmar*

## **Mertens House Building**

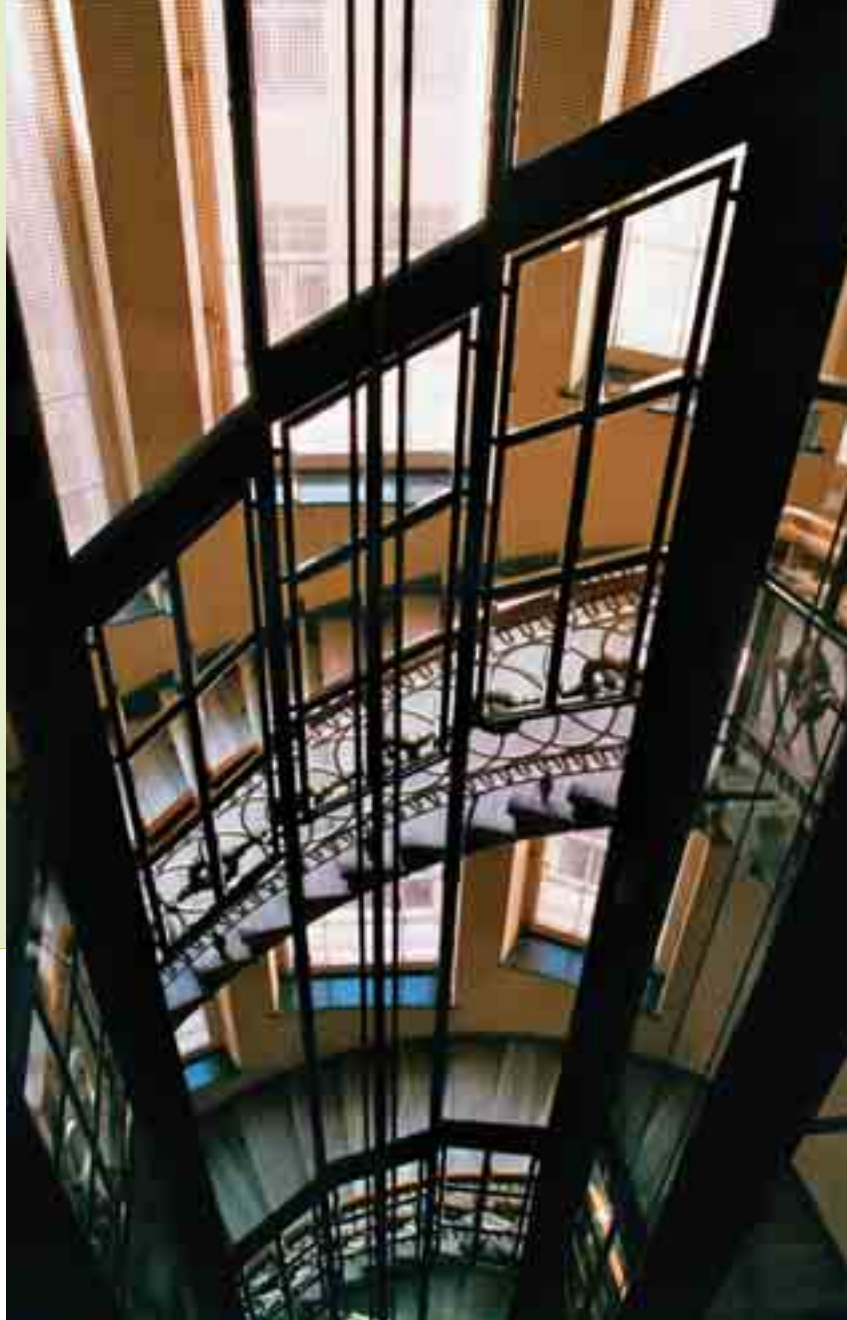
The old mesh wire had to come off completely and be replaced by new wire that would fulfill the requirements of the Russian standard of 1992, when wire mesh was still allowed. This special exemption was found by the technical authorities in conjunction with the Russian State Historic Heritage Authority. All broken glass has been replaced and complies with ruling codes. Glass surfaces not broken were fitted from the back with a special foil to achieve similar properties to modern safety glass. The gaps between the single-shaft glass panels do, however, not comply with ruling codes, owing to the historic shaft appearance. Since the lift is used only by a limited number of persons, exemption could be granted for this deviation, as well.

Above: The new wire mesh had to fulfill modern requirements.
